METEOROID AND DEBRIS IMPACT FEATURES DOCUMENTED ON THE LONG DURATION EXPOSURE FACILITY

A Preliminary Report

Compiled by Members
of the LDEF Meteoroid
and Debris Special
Investigation Group

August 1990

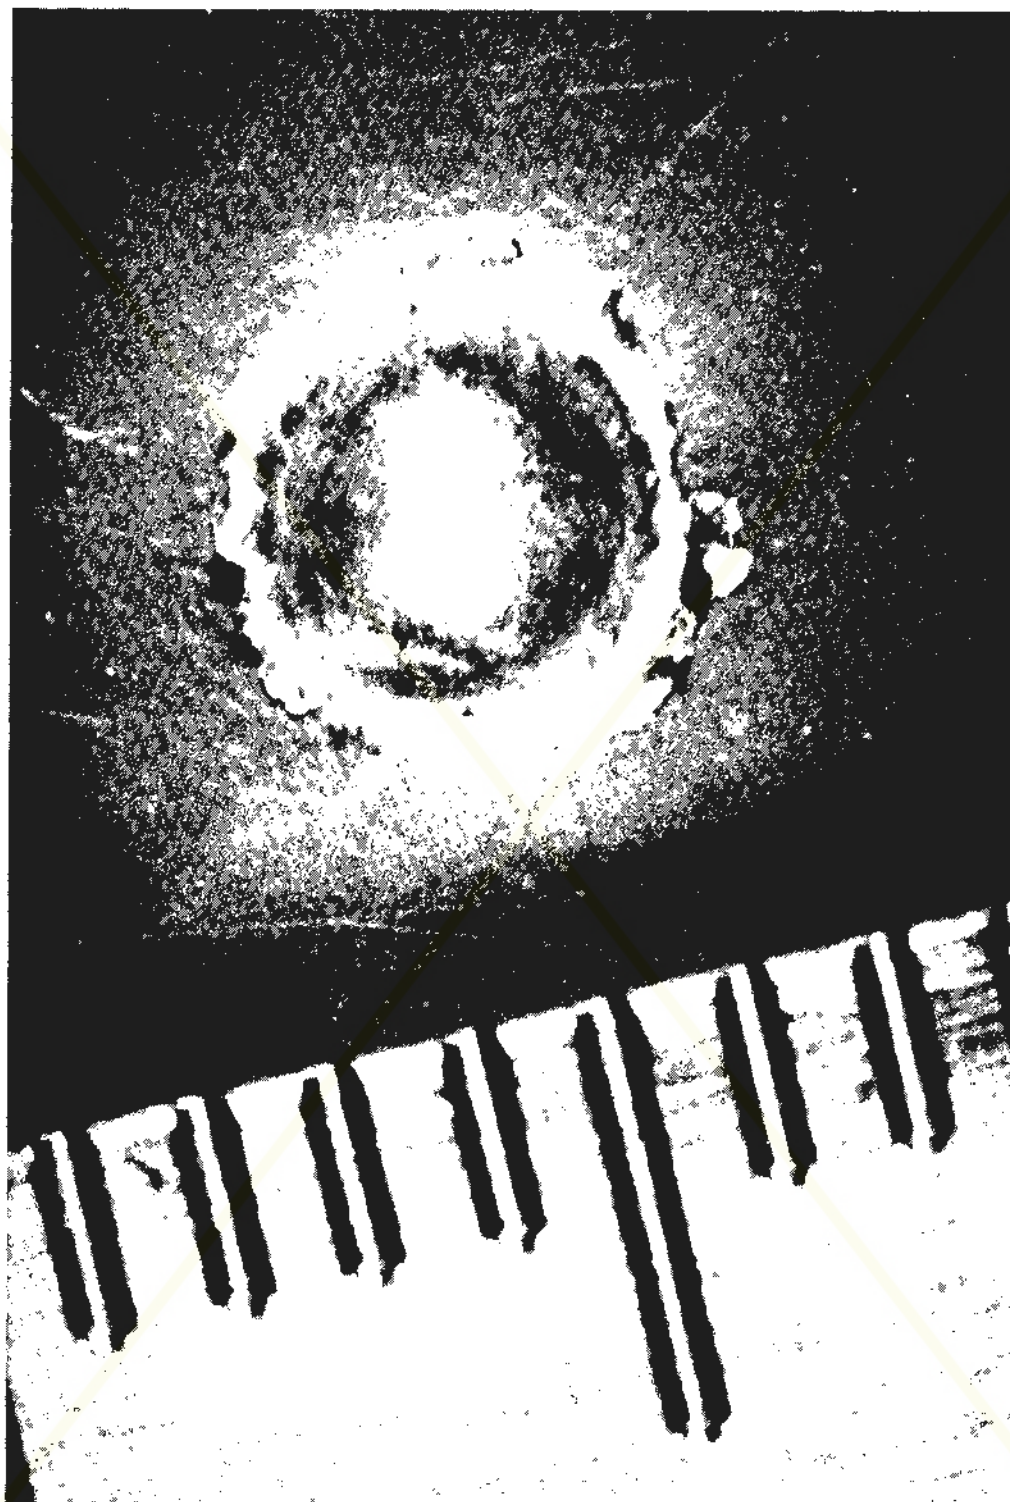
Figure 2. Photograph of a symmetrically-shaped crater in an aluminum surface. Most features on LDEF were of this type. Small divisions on scale are in millimeters.

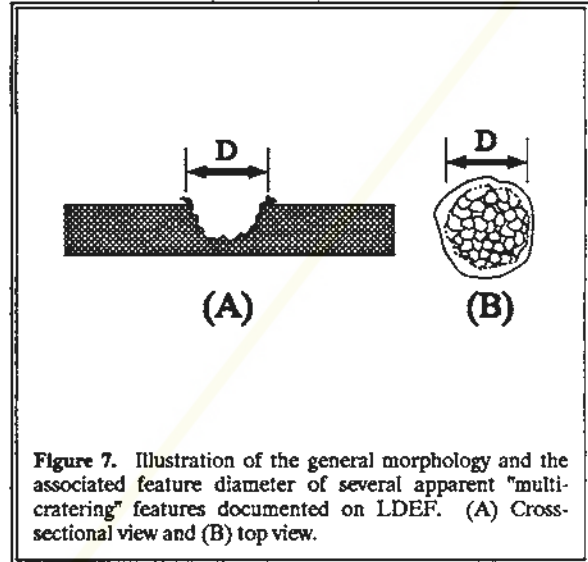
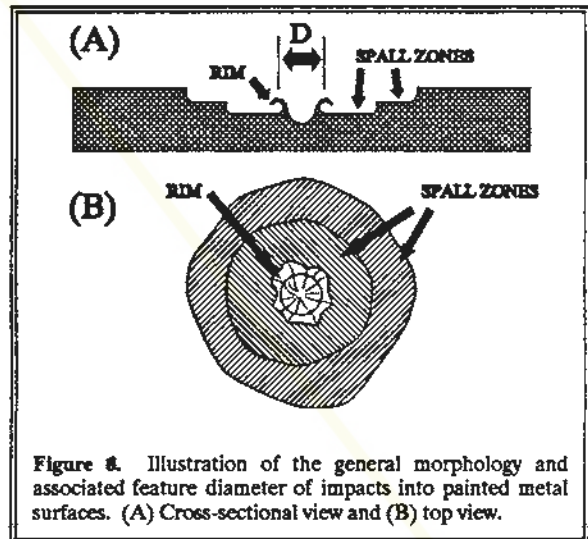
Impacts >0.5 mm in diameter into painted metal surfaces generally produced associated spall zones in the paint which extended for several crater diameters around the standard-shaped crater in the underlying metal surface (Figures 8 and 9). On thin aluminum panels coated with several layers of paint there were frequently large, front-surface delamination zones extending tens of crater diameters around the impact sites. In these instances, the top layer of paint was apparently blown off of the surface by acoustic forces propagating through the thin panel. In many cases, diameters for these zones were measured and recorded in the comments field of the digitized image files.

Figure 9. Impact into one of the paint specimens on an experiment-tray clamp. This particular feature was the largest impact feature found on the numerous tray clamps. View measures approximately ~6.5 cm across.

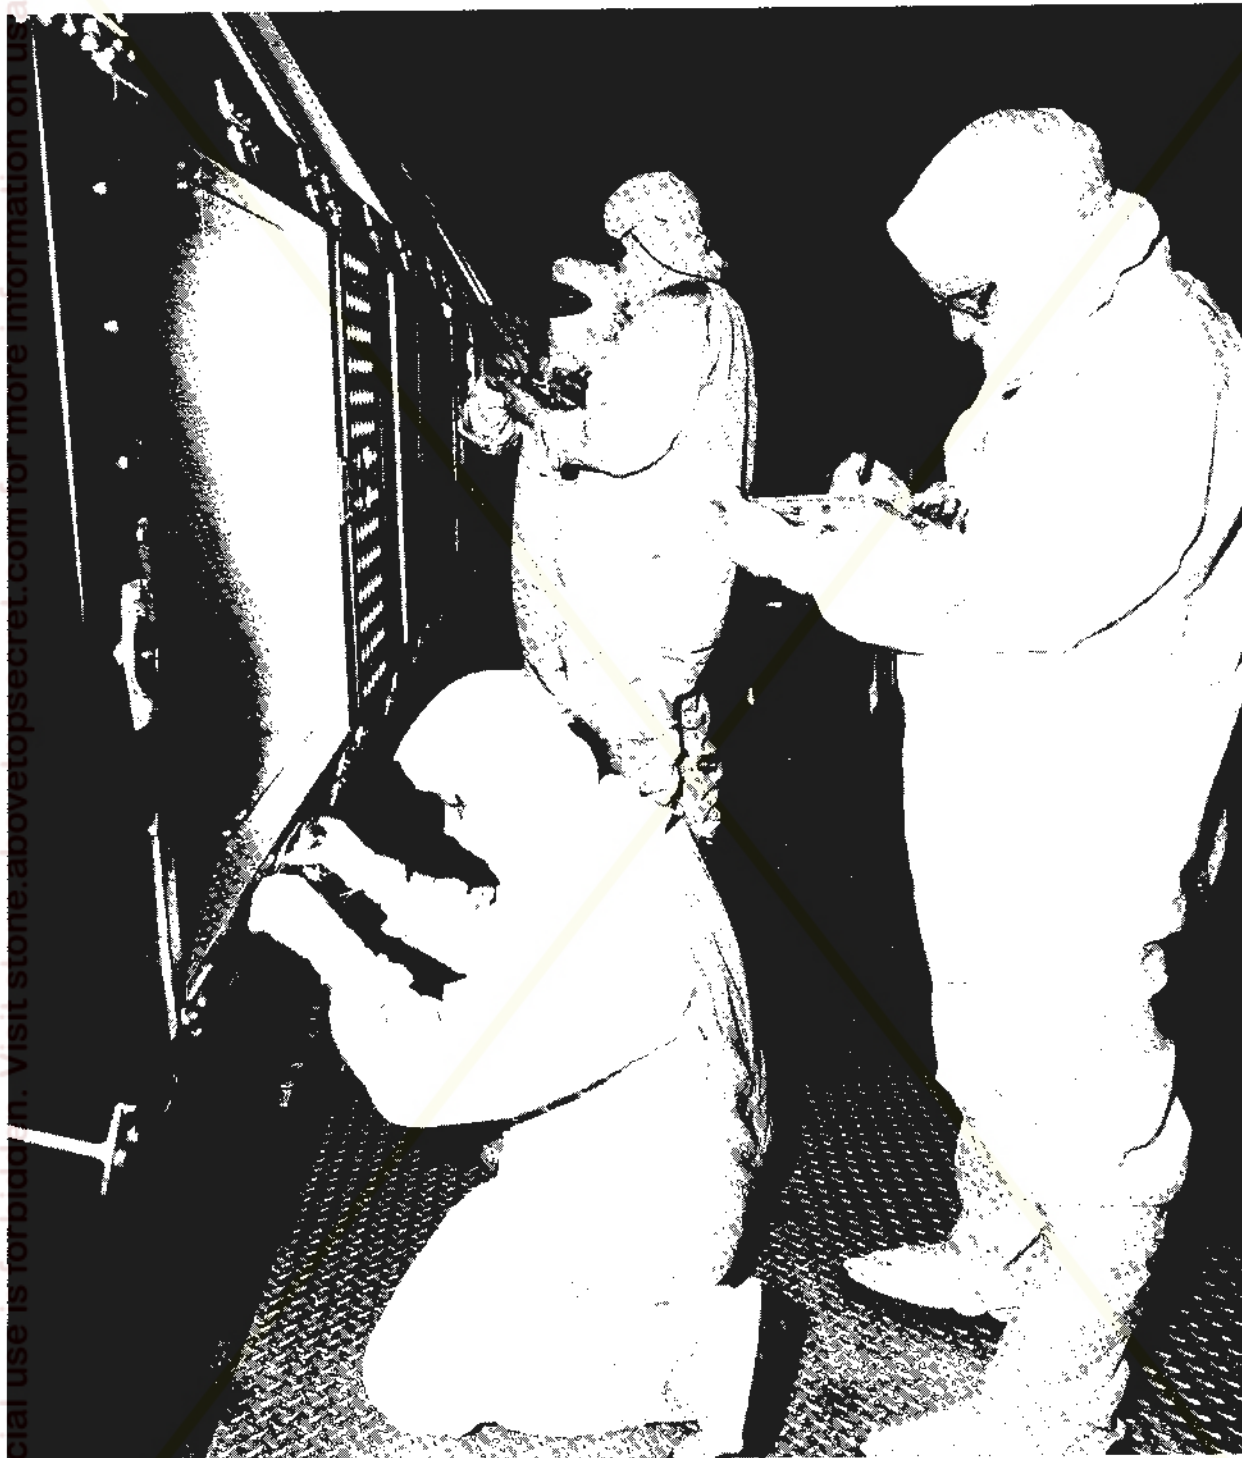
Figure 21. Members of the M&D SIG performing the BOLTS, CLAMPS, SHIMS, AND EXPERIMENT TRAY FLANGES/LIPS INSPECTION AND BOLT ORIENTATION SURVEY prior to the commencement of the deintegration operations.

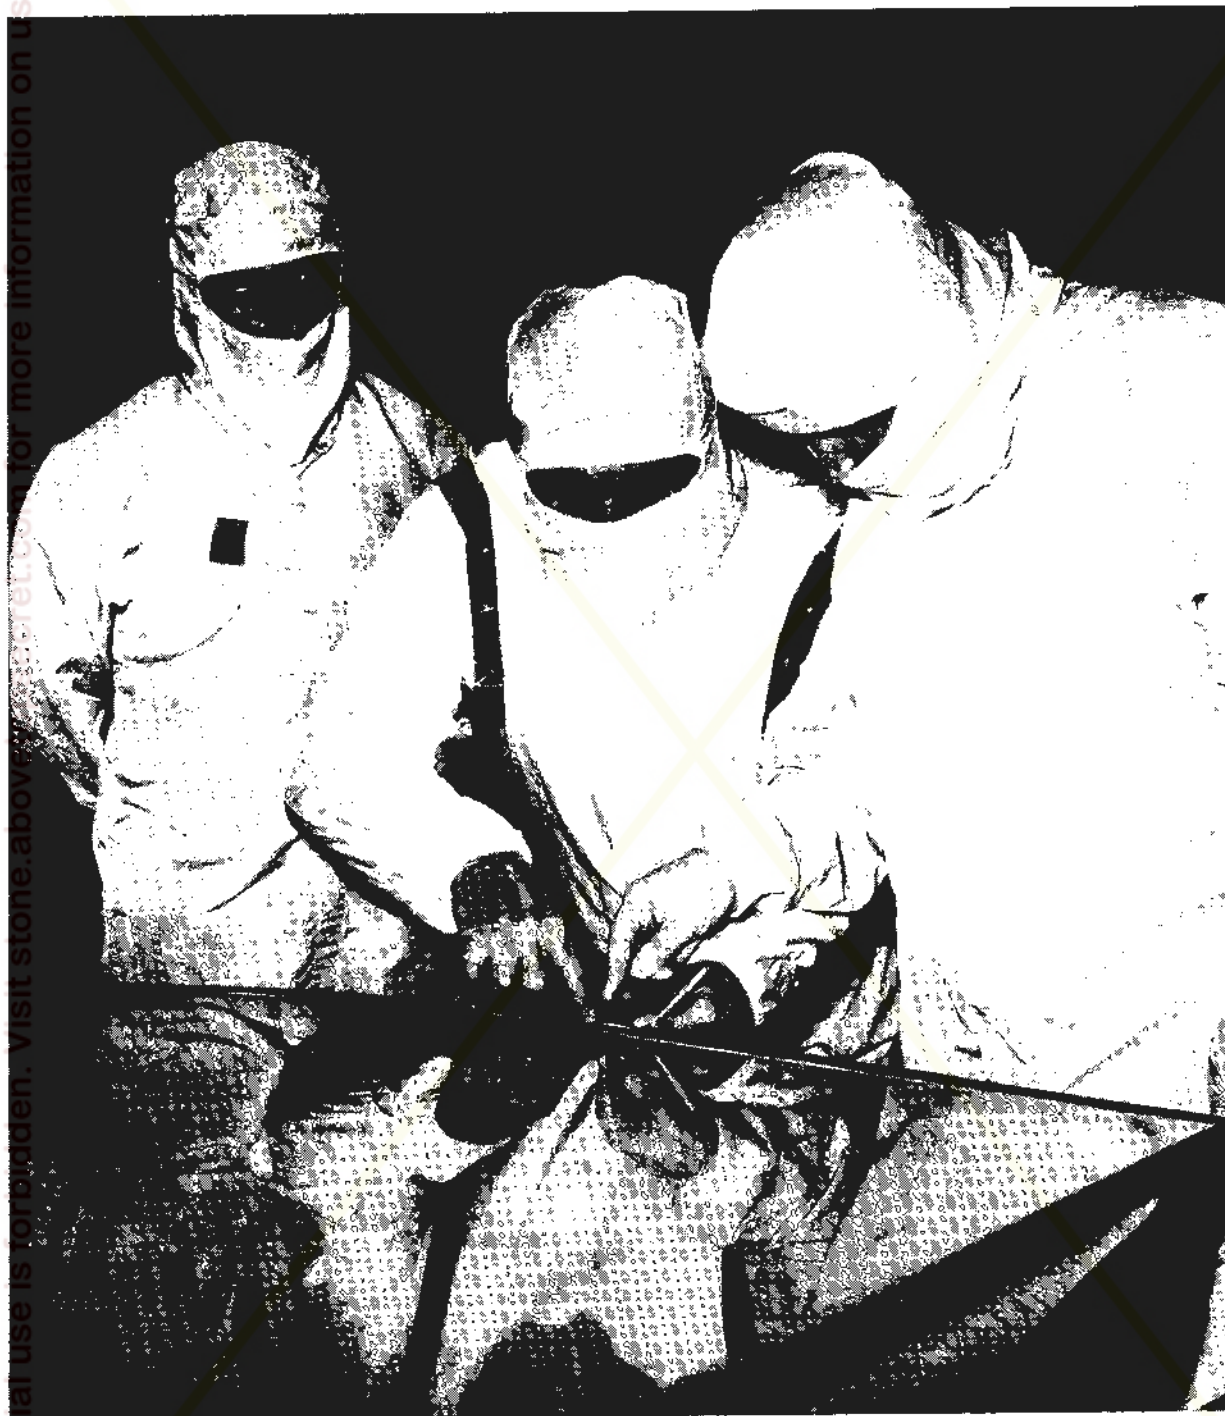
Figure 23. M&D SIG and Ground Operations personnel removing small sections of the experiment-tray cover gasket to prevent damage and contamination to features residing on the experiment-tray flanges.

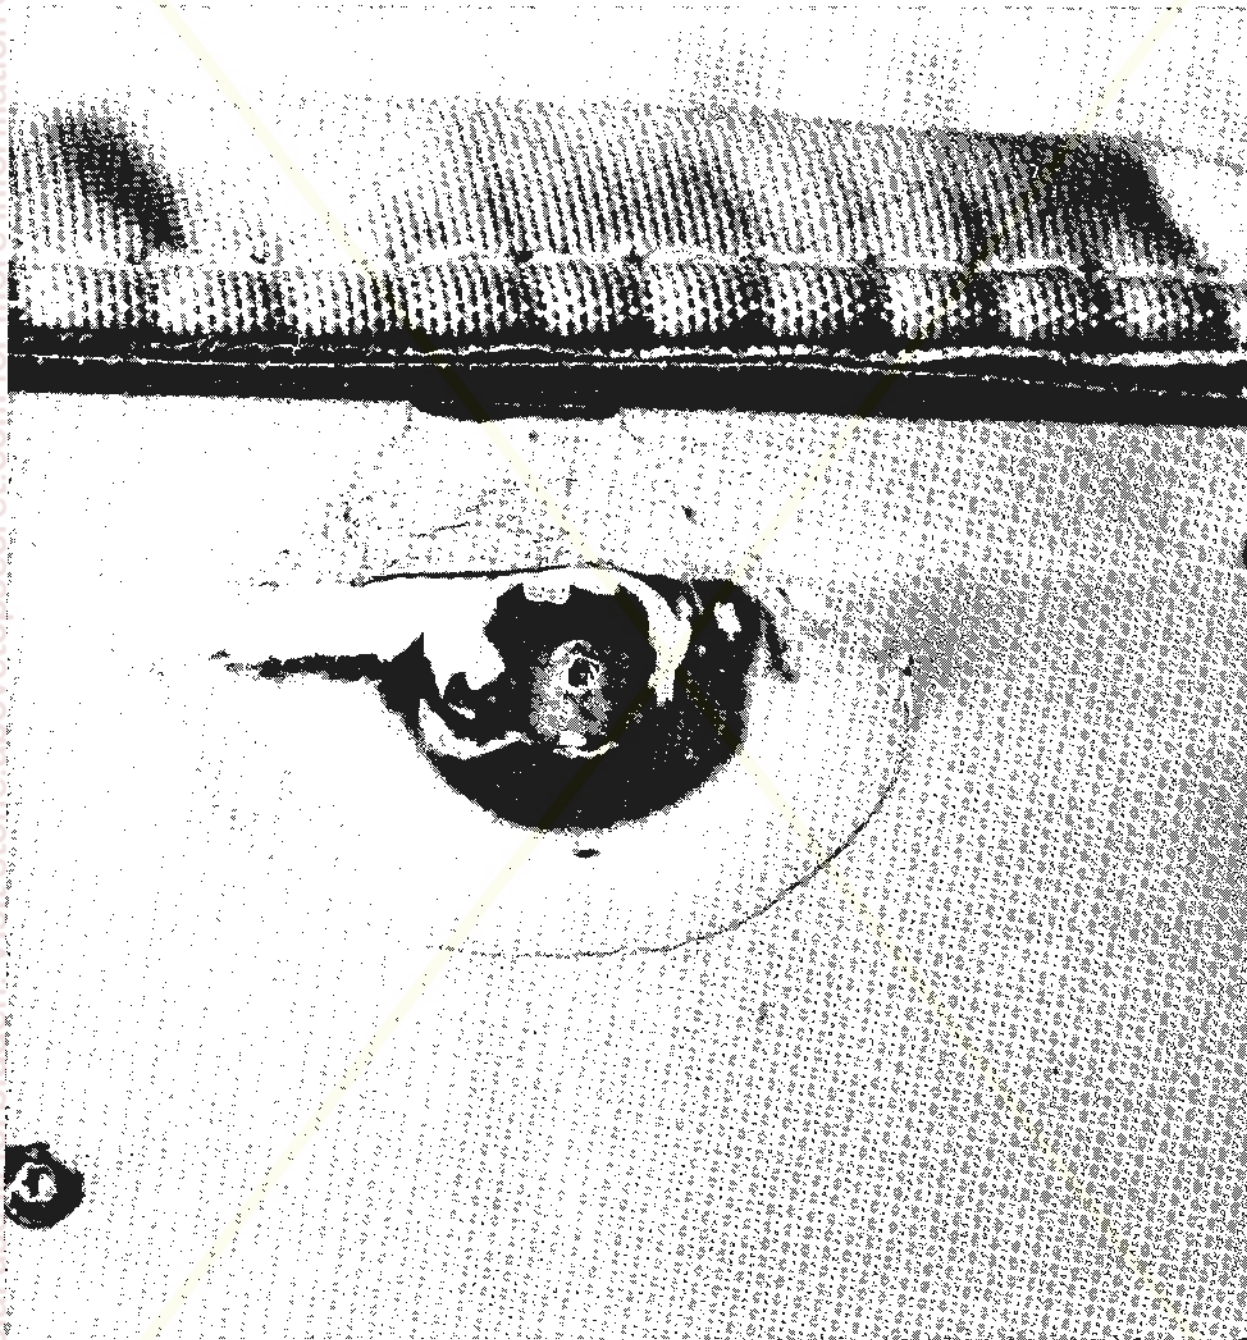
Figure B10-2. This is a view of a large impact with spall across one of the heat-pipe covers. View measures approximately 4 cm across.

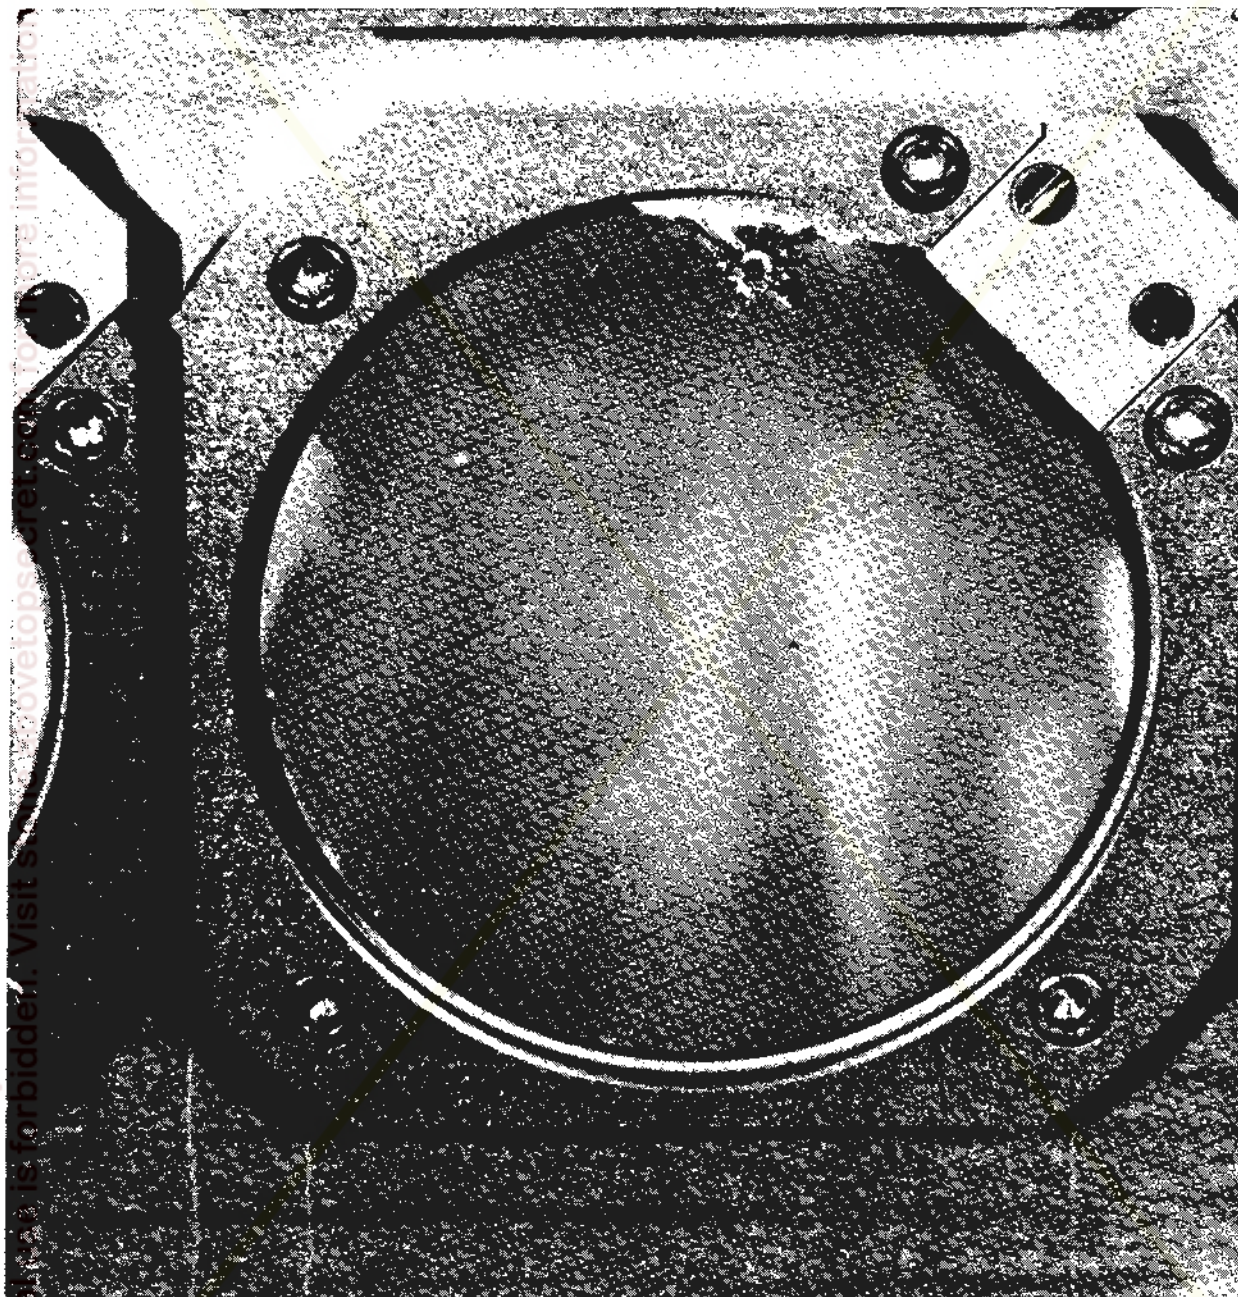
Figure B12-2. This is a view of impact feature #17, with associated shattering, onto a MOS detector. View measures approximately 9 cm across.

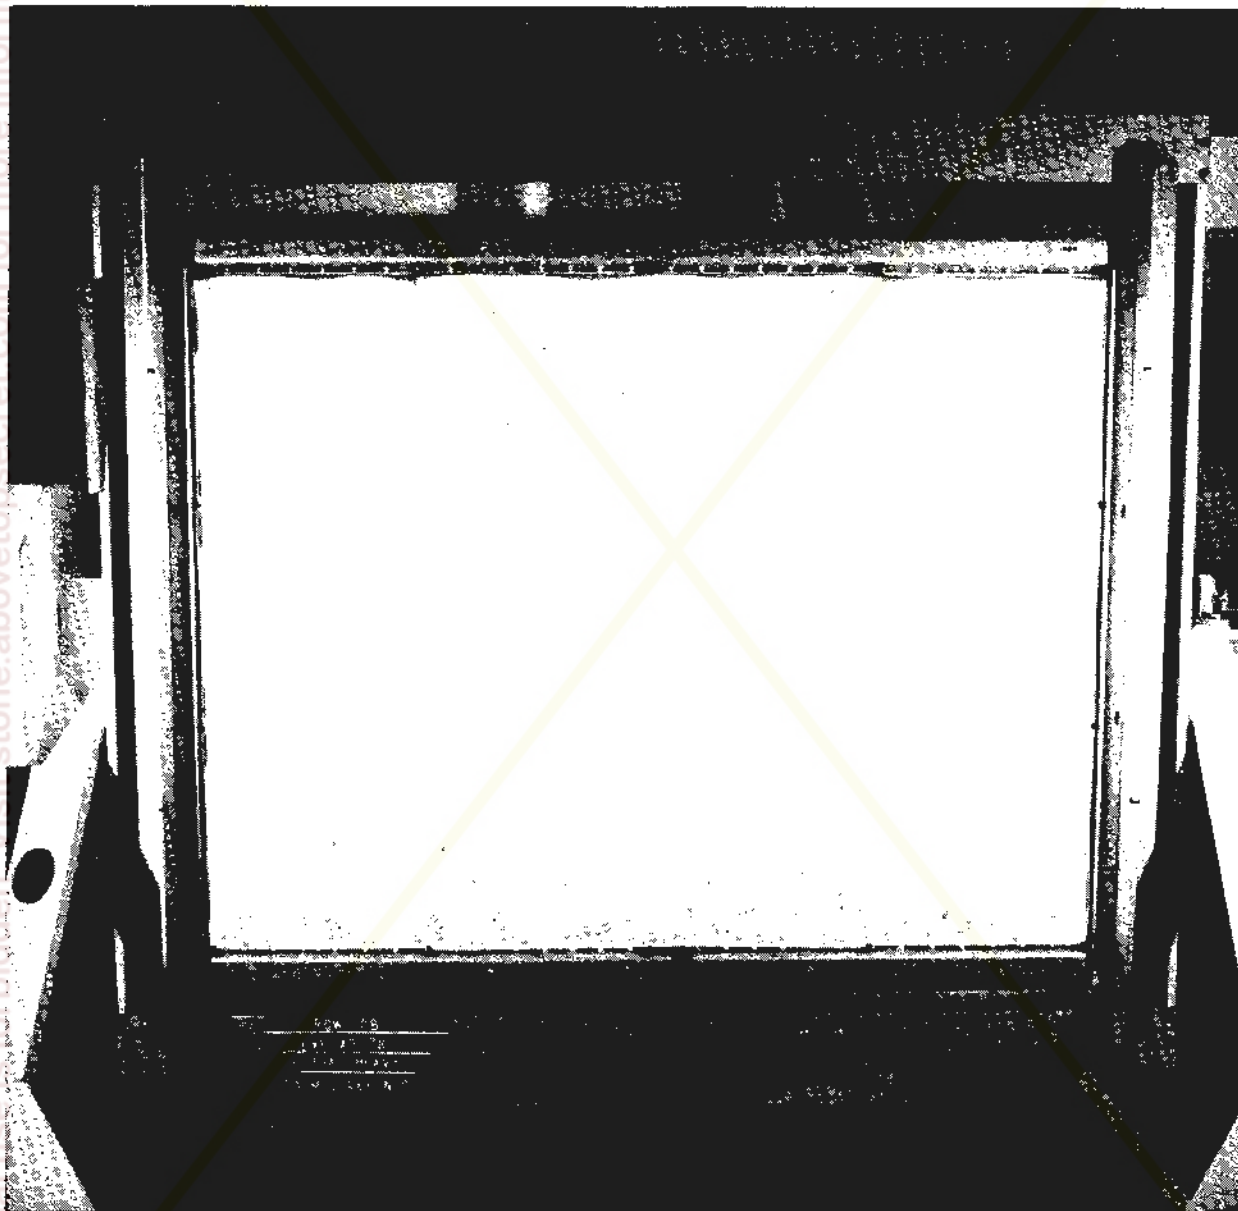
Figure C08-1. This post-deintegration view shows the front of the entire C08 experiment thermal blanket. Oxygen erosion has given this blanket a frosted appearance. The large impact (#94, with a streak) on the lower right is shown in Figure C08.

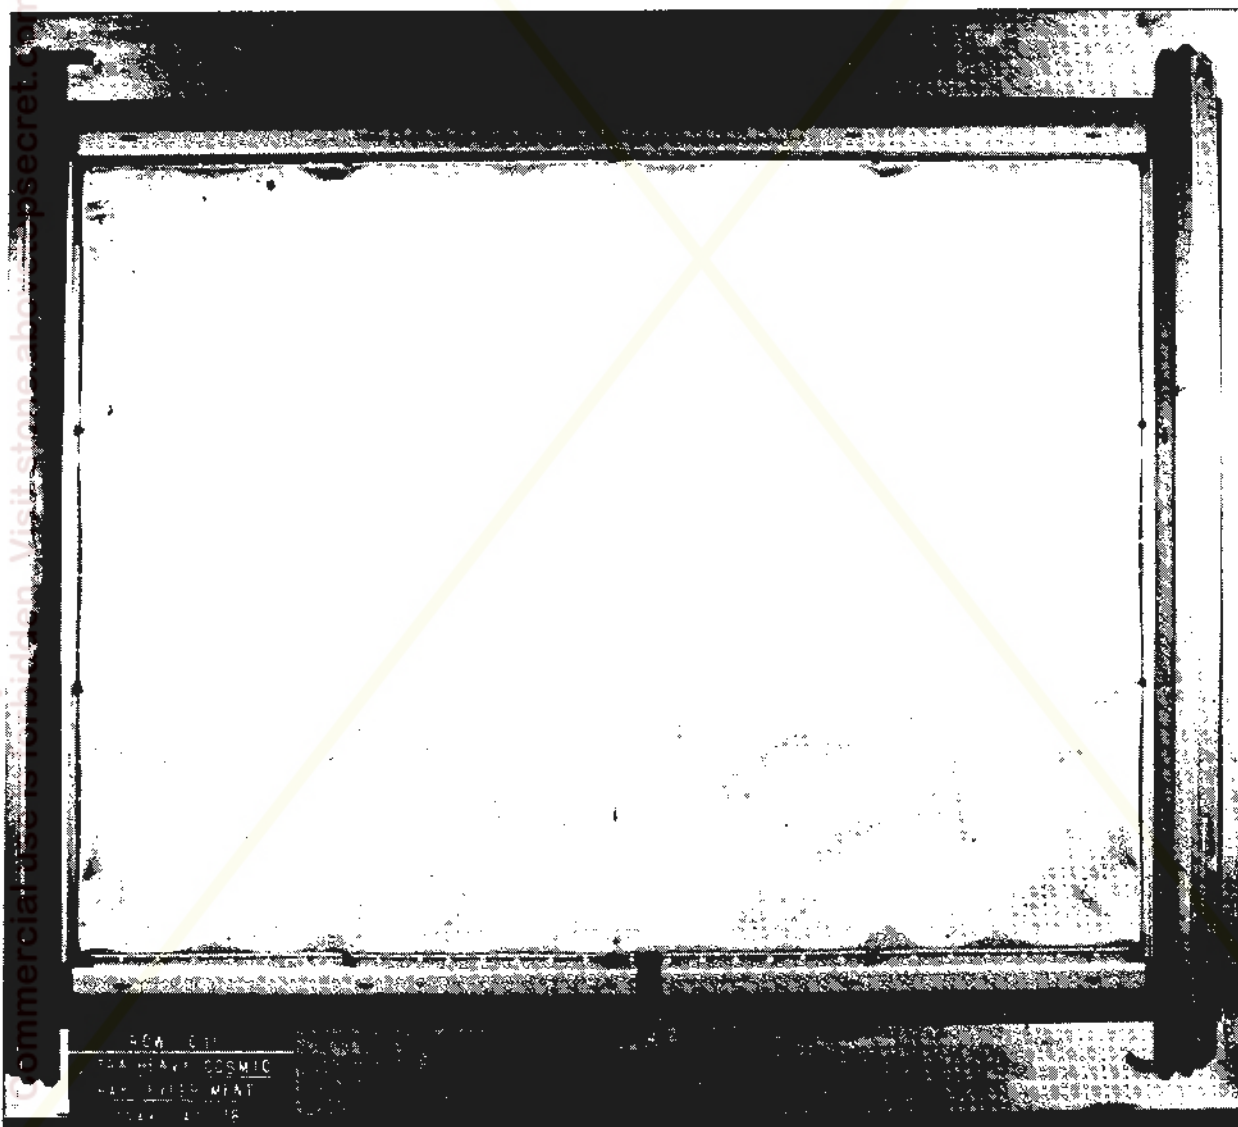
Figure C11-1. This post-deintegration view shows the front of the entire C11 experiment thermal blanket. Oxygen erosion has given the blanket a frosted appearance. The double impact feature in the center of the blanket is shown in Figure C11.

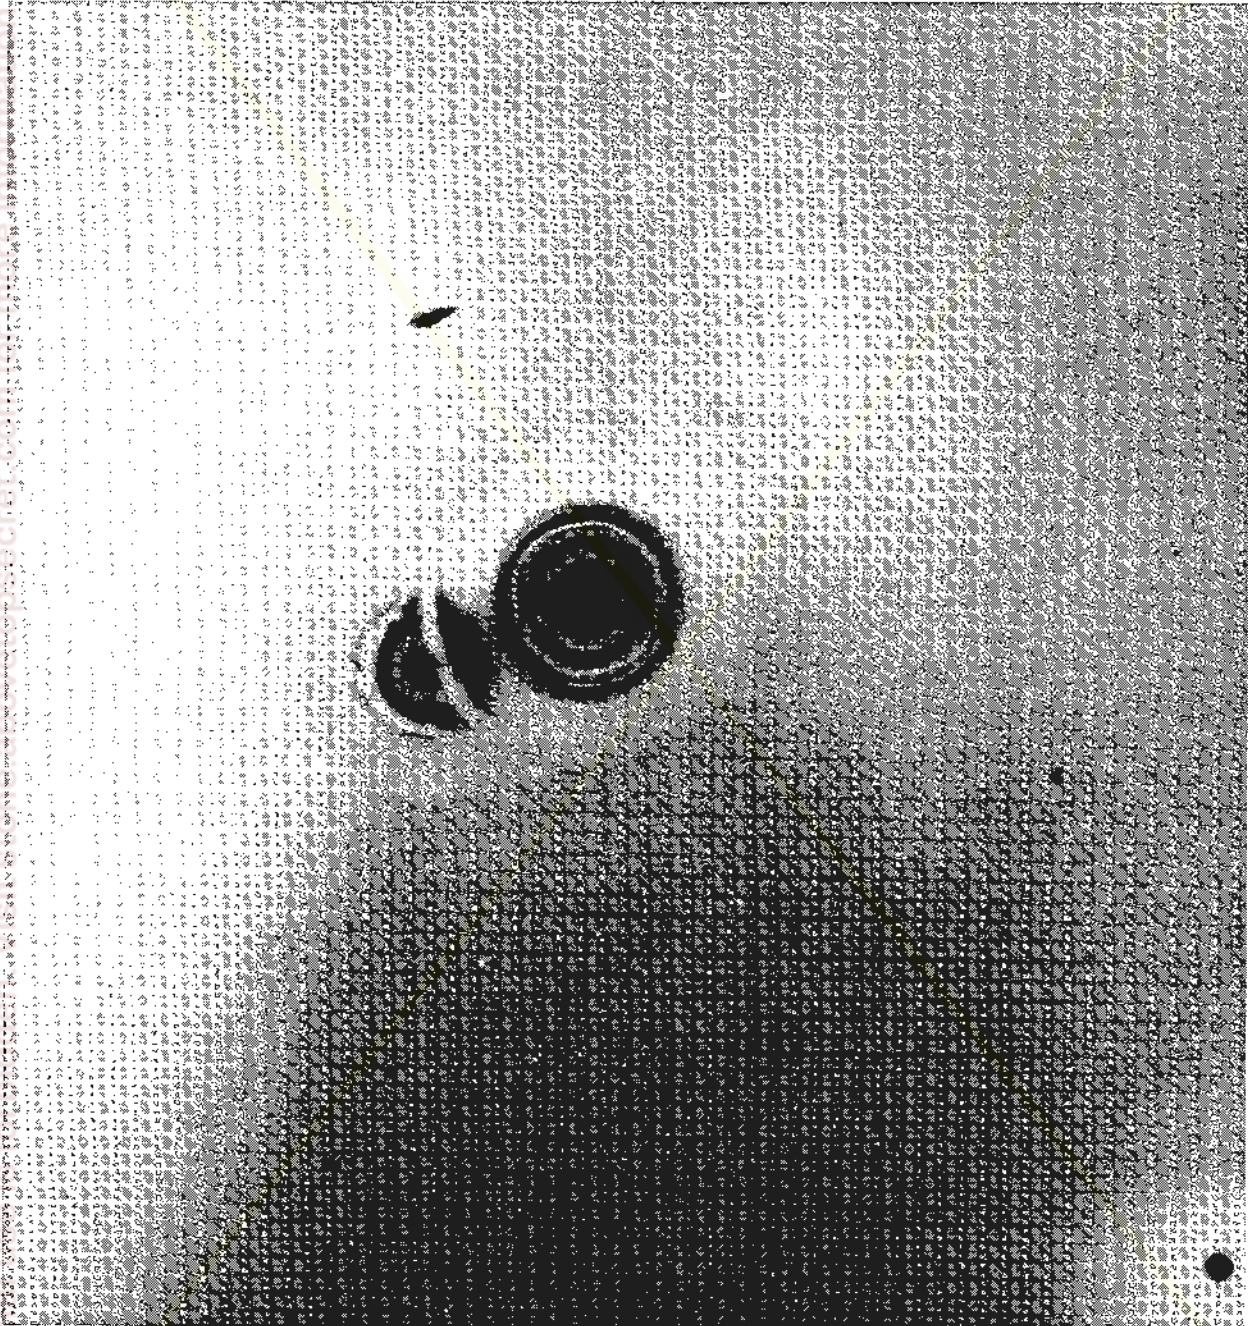
Figure C11-2. This is a pair of impact penetration features on the C11 thermal blanket, both with concentric rings. The rings of the smaller feature are incomplete, possibly related to the formation of the larger impact feature. View measures approximately 9 cm across.

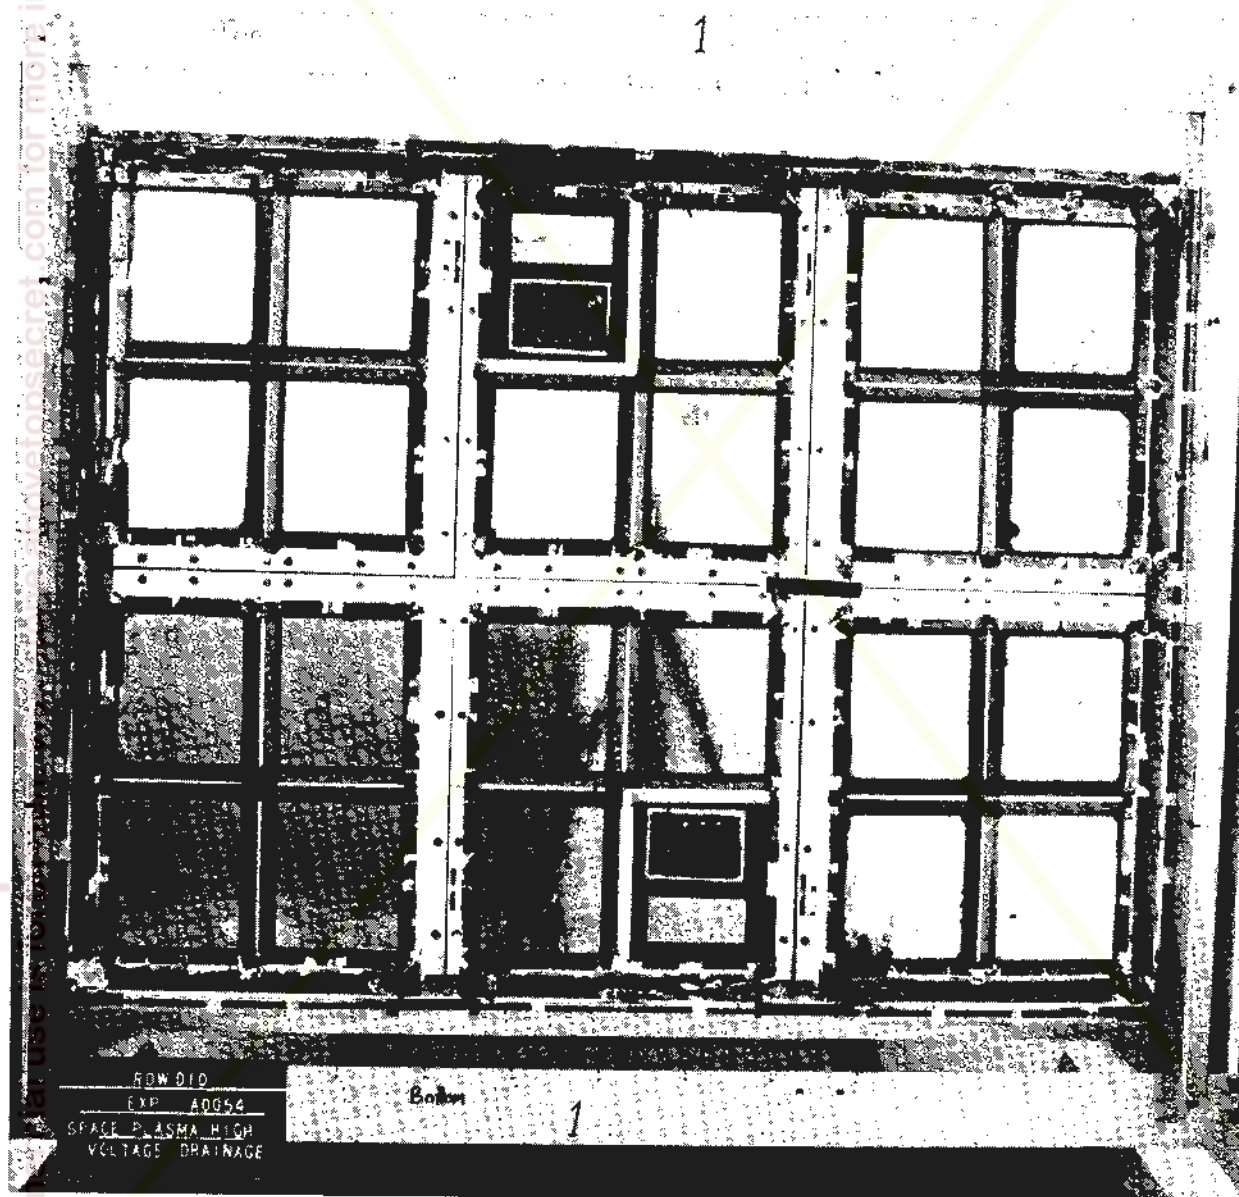
Figure D11-1. This post-deintegration view shows the front of the entire D11 experiment thermal blanket. Some impact features are apparent.

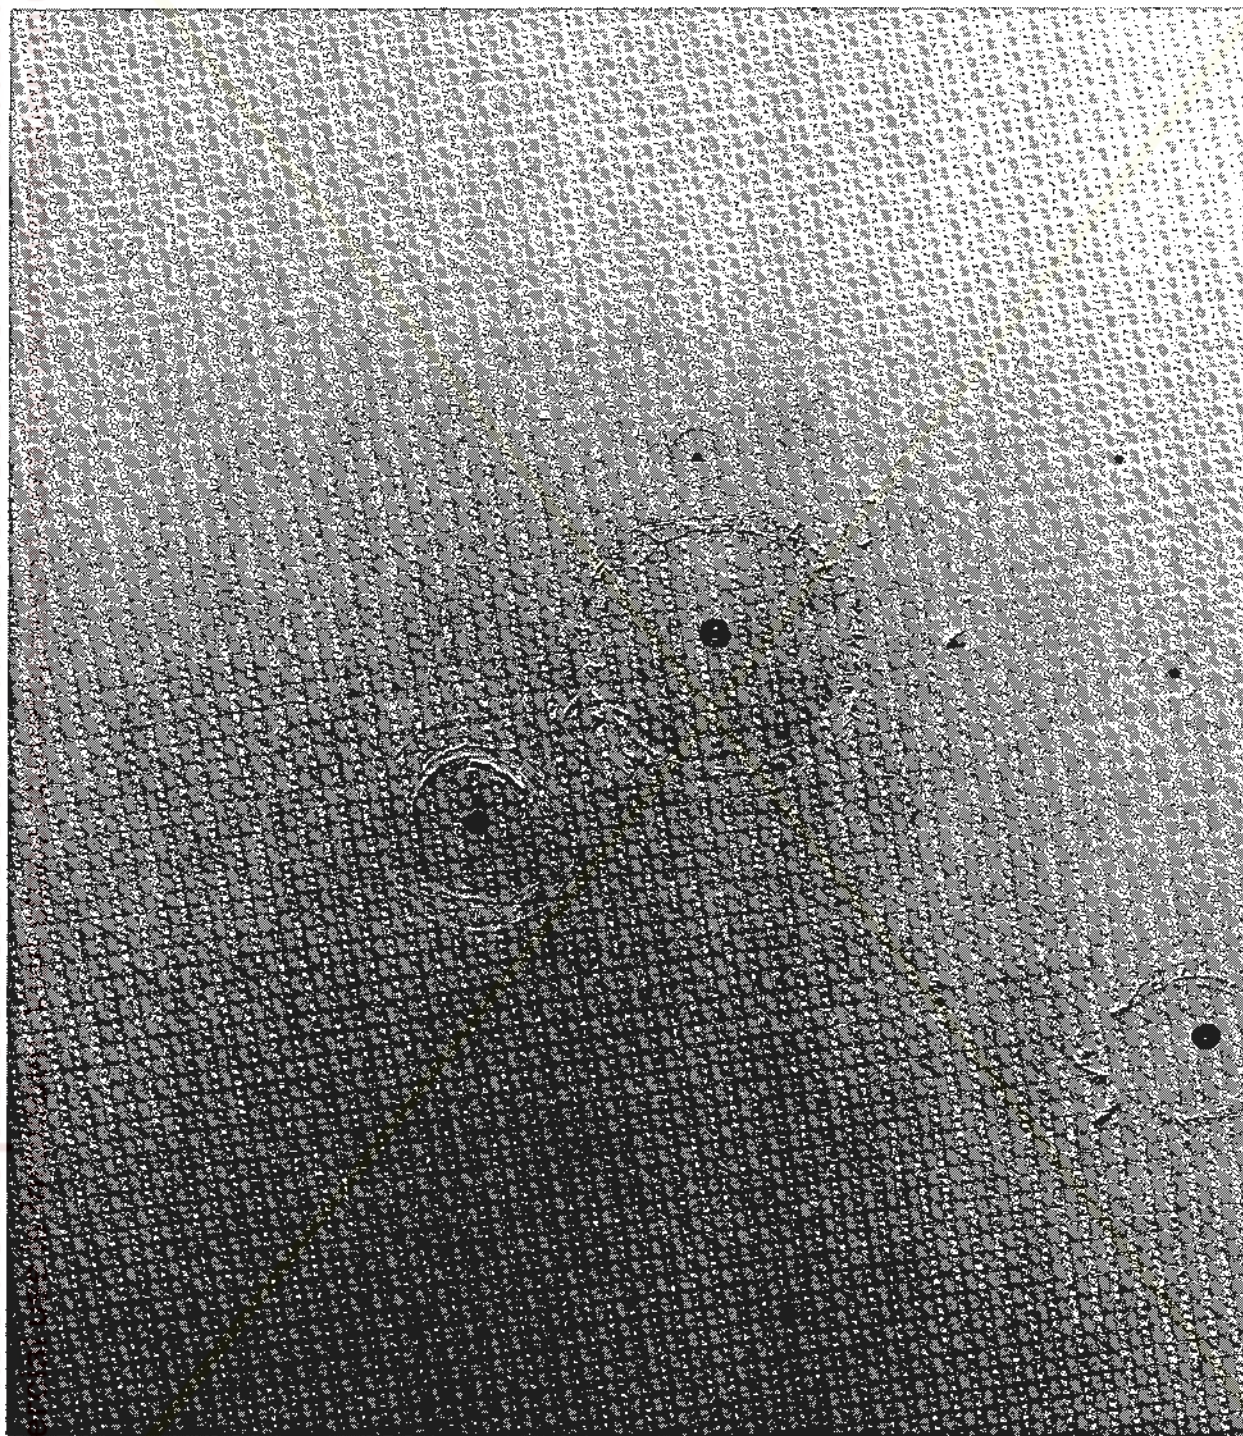
Figure F08-2. Impact features into the white-painted aluminum surface. Each crater extends through the paint into the aluminum substrate. Paint delamination features surround each impact. View measures approximately 8 cm across.

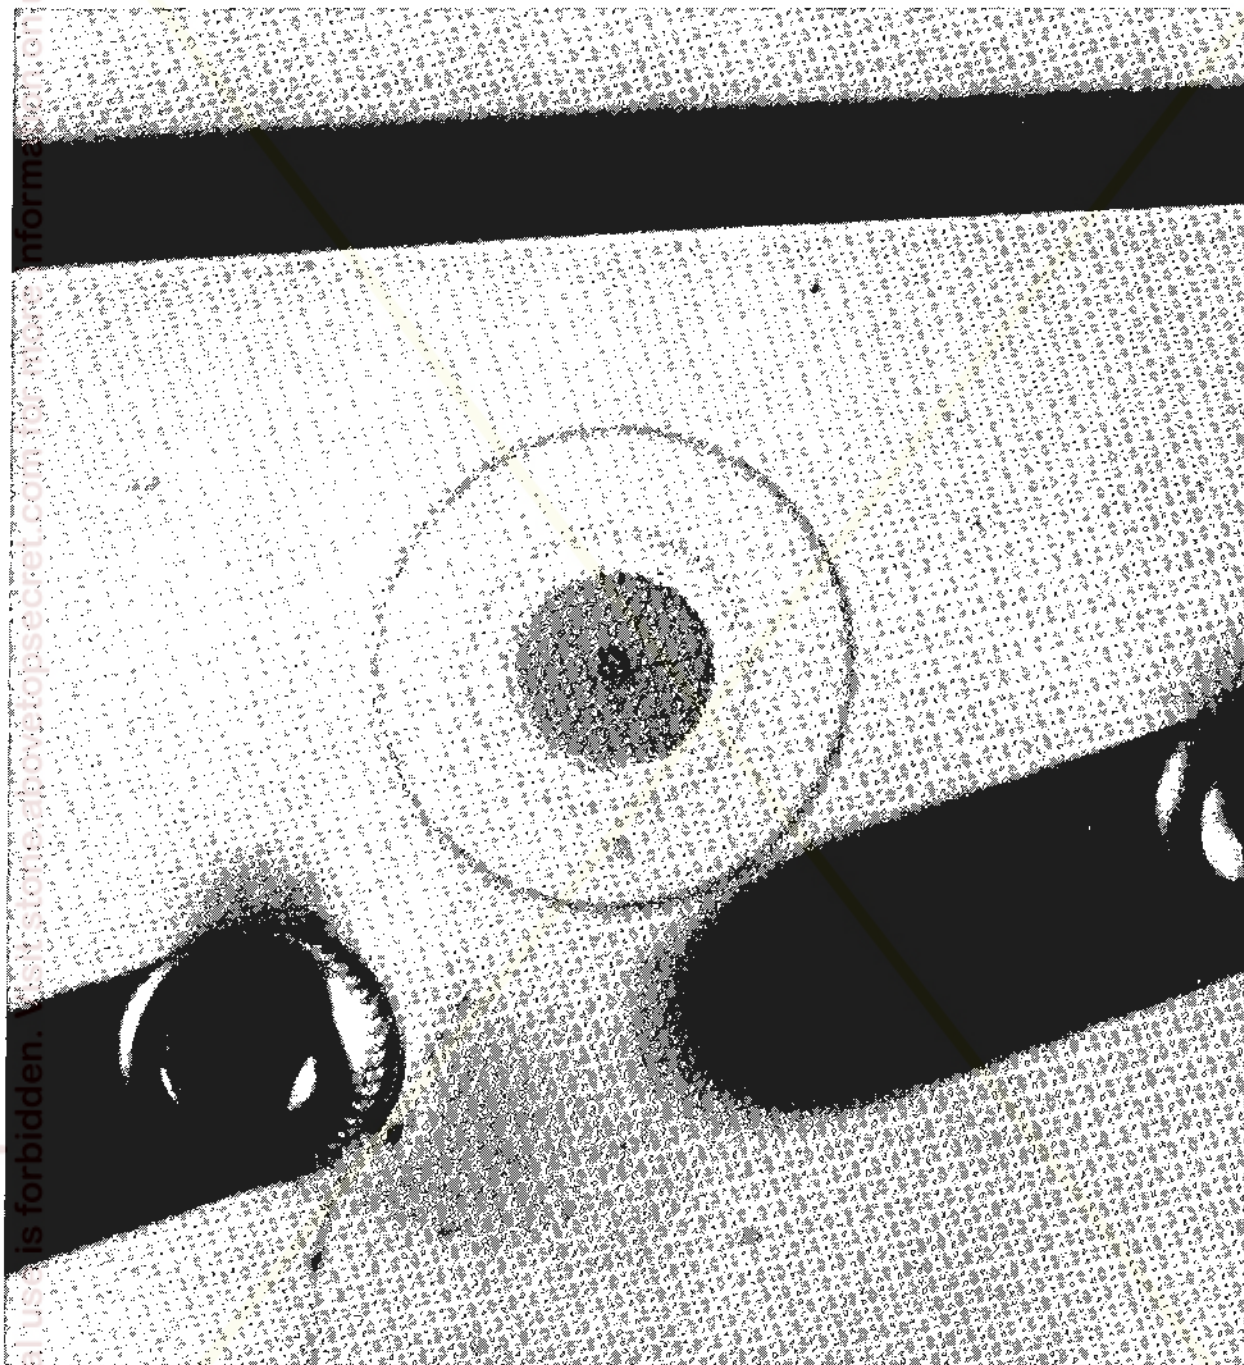
Figure F08-3. A concentrically-ringed impact feature into the white-painted aluminum surface. View measures approximately 4 cm across.

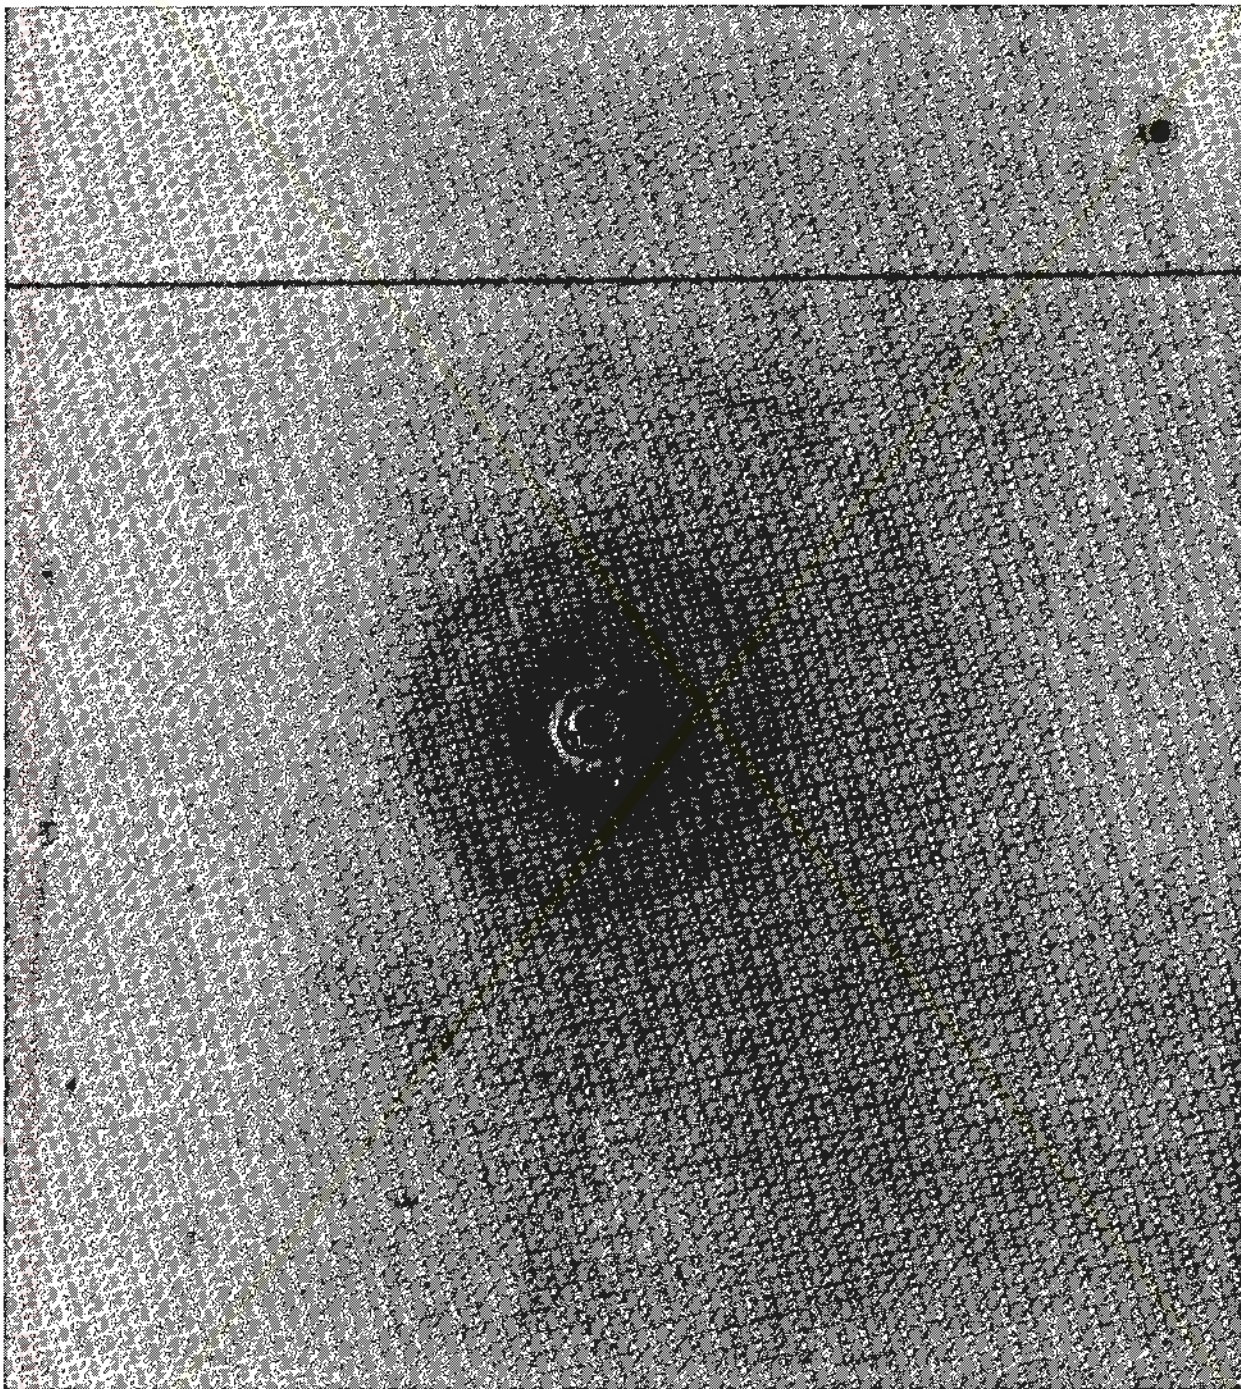
- Figure F09-1.** This pre-deintegration view shows the front of the entire F09 experiment tray, largely showing only the thermal blanket which remained once loosely-adhering foil samples had been removed. A arrow indicates the impact feature shown in Figure F09-2.
- Figure F09-2.** A concentrically-ringed impact feature into the white-painted aluminum surface. View measures approximately 8 cm across.

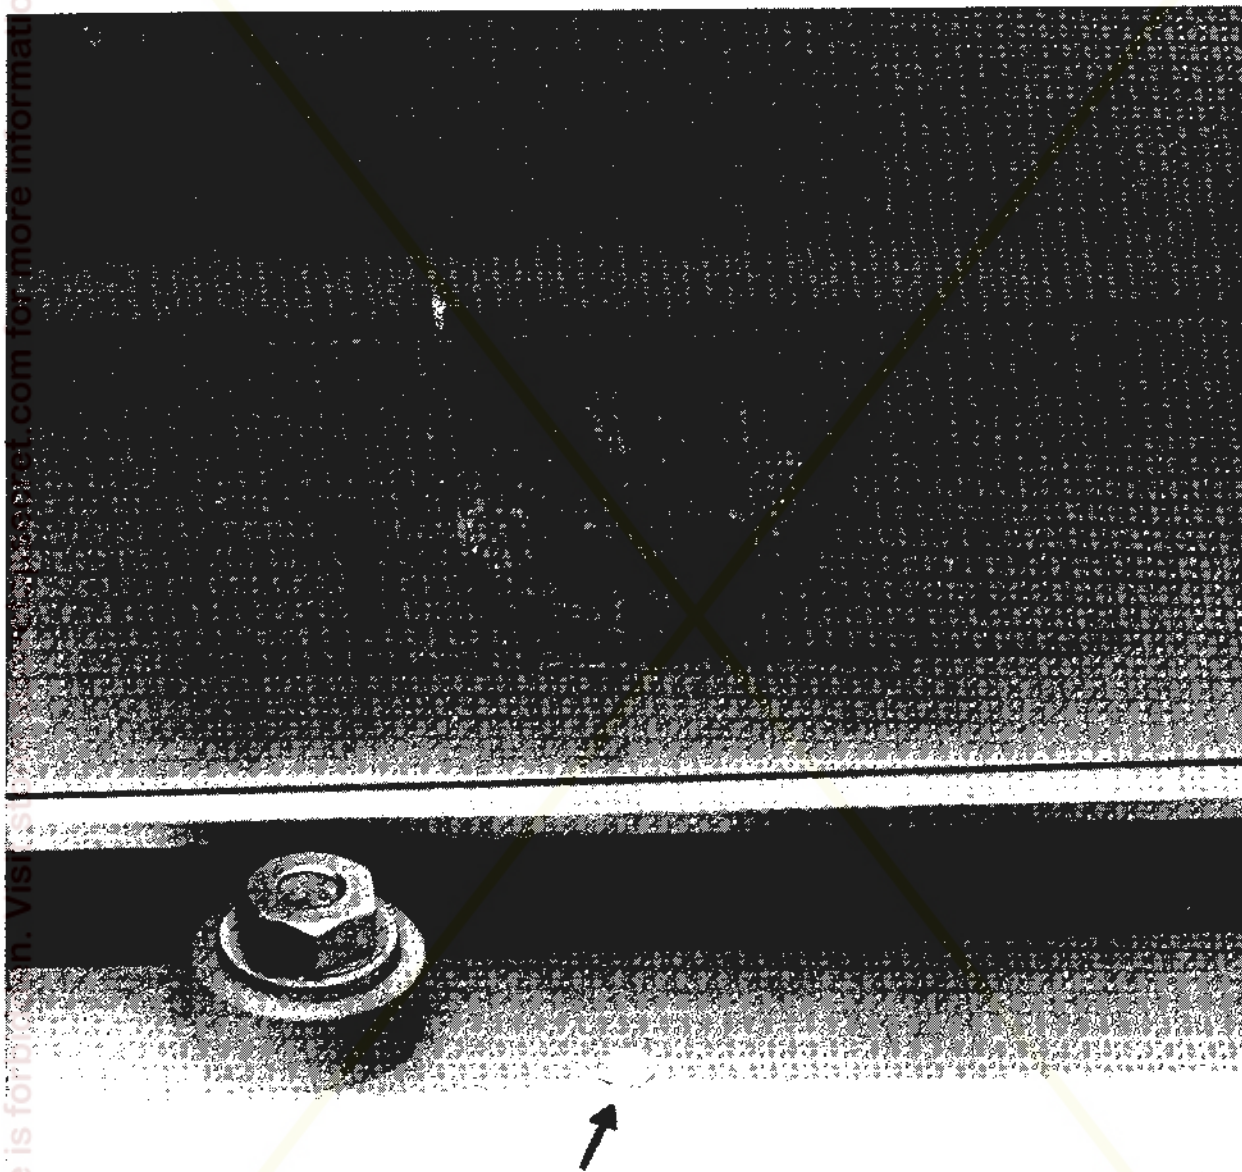
Figure H09-2. View of a crater (indicated by arrow) located in aluminum with a large adjacent ejecta pattern. The feature was located inside one of the detector housings. This view measures approximately 12 cm across.
